# Long Creek Watershed Tour 2005

Supplemental Handouts Containing Photographs,  
Maps, and Data Related to the Conditions  
of the Stream

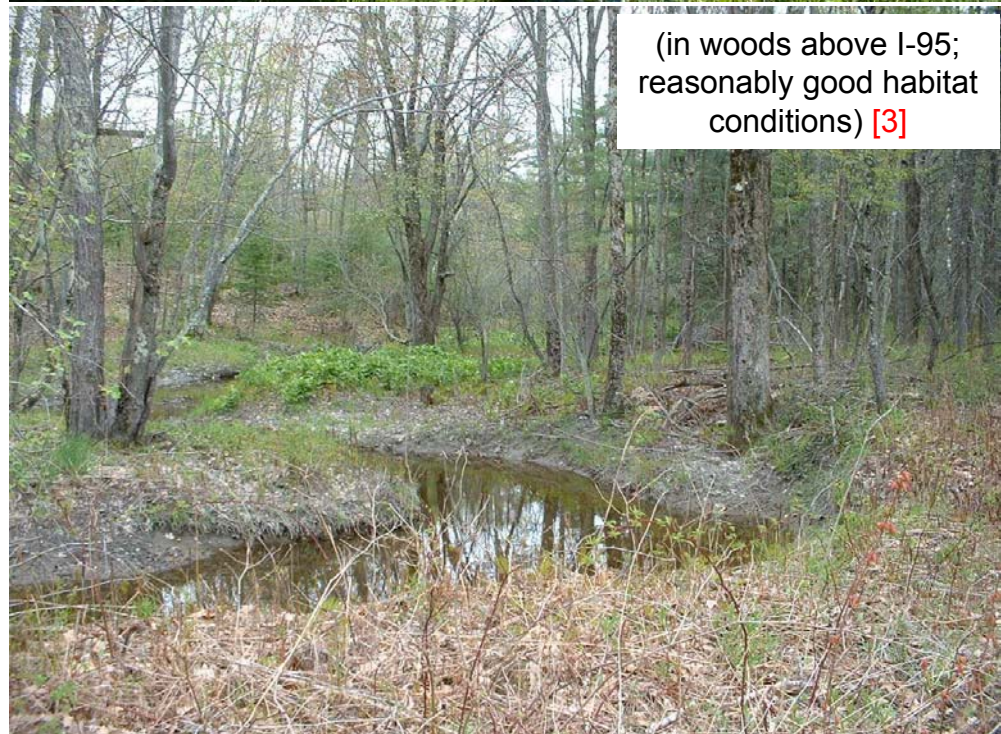
(in woods above I-95;  
reasonably good habitat  
conditions) [3]

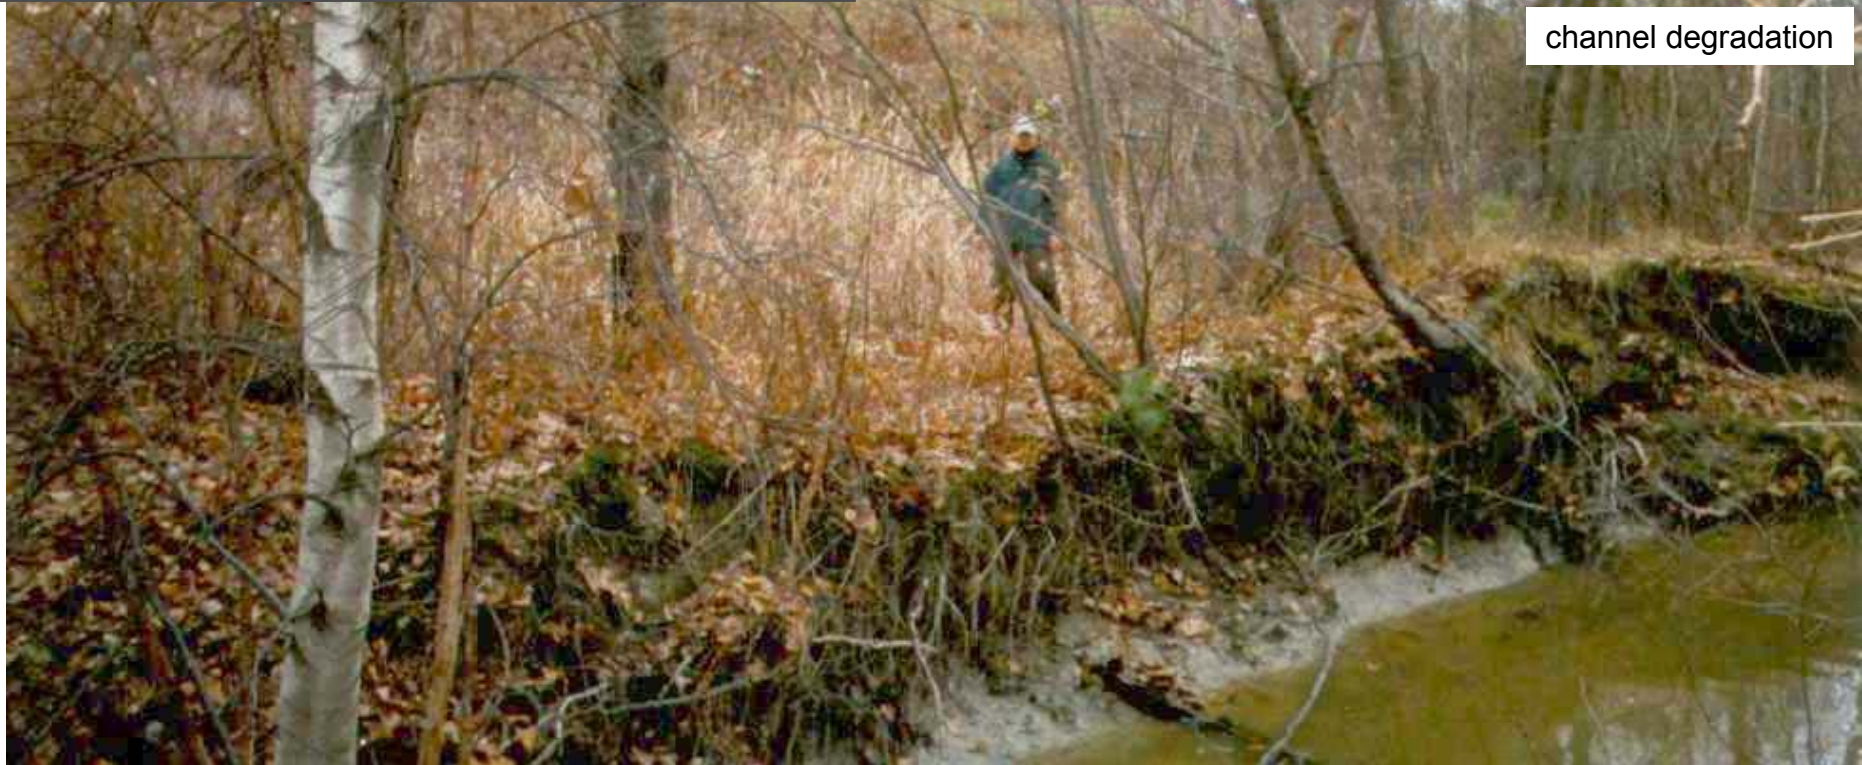
channel degradation

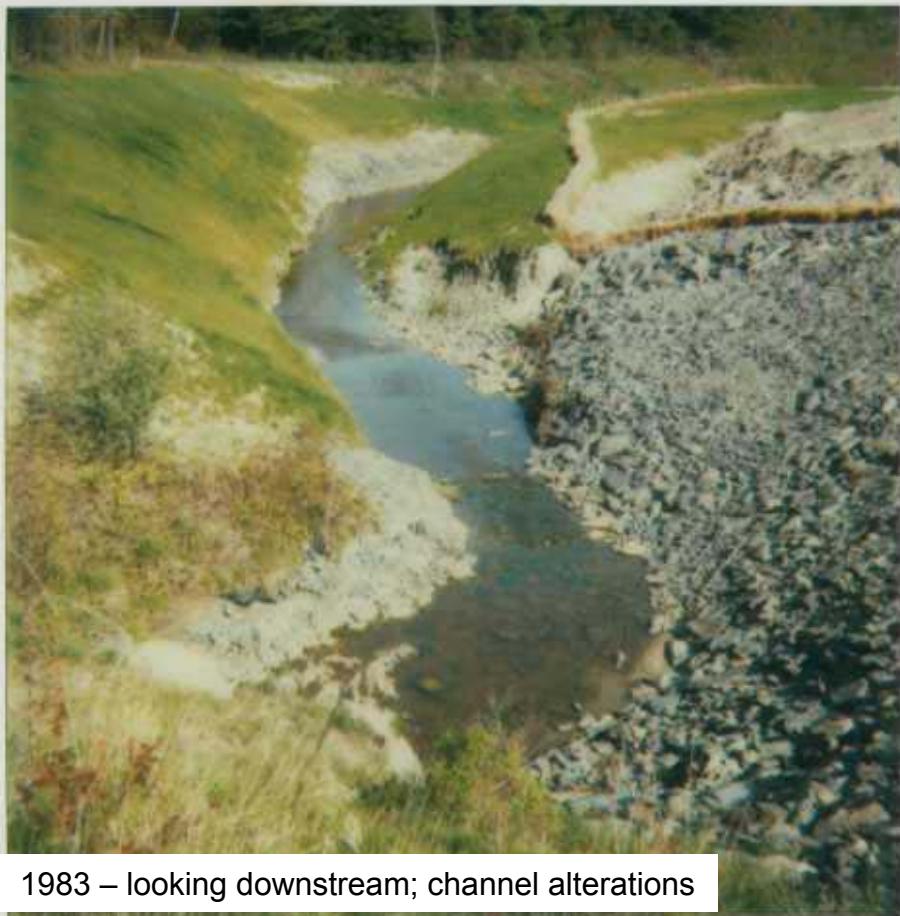
1983 – looking downstream; channel alterations

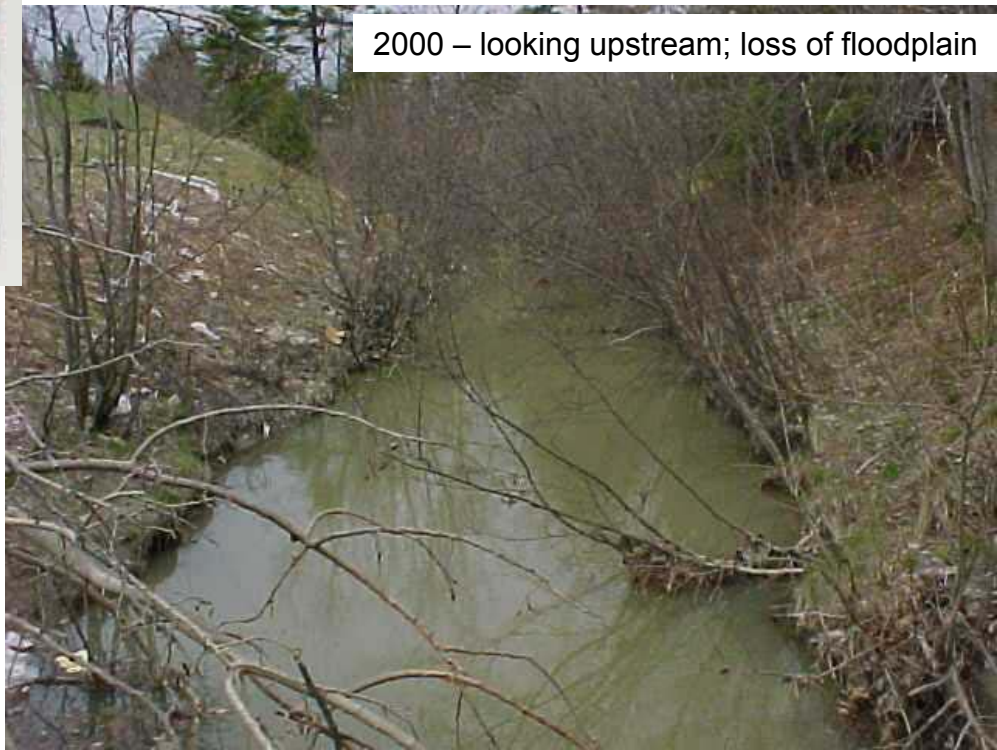
2000 – looking upstream; loss of floodplain

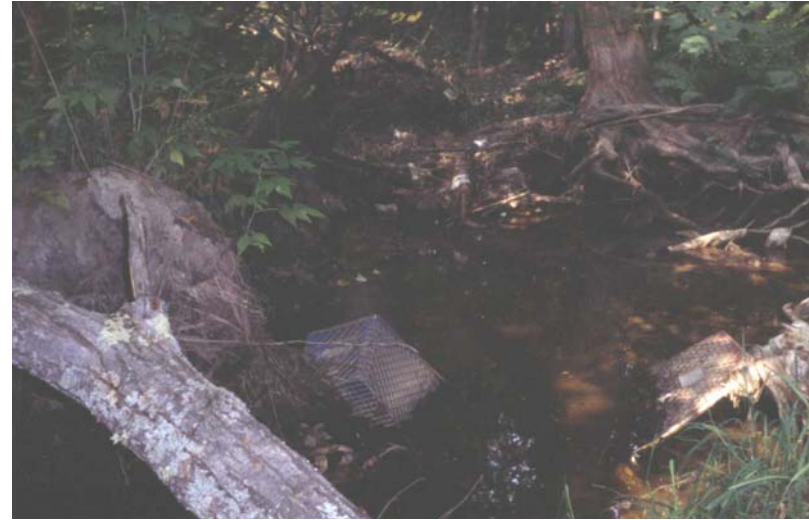
trash (e.g., shopping carts, tires, etc.); debris; channel degradation

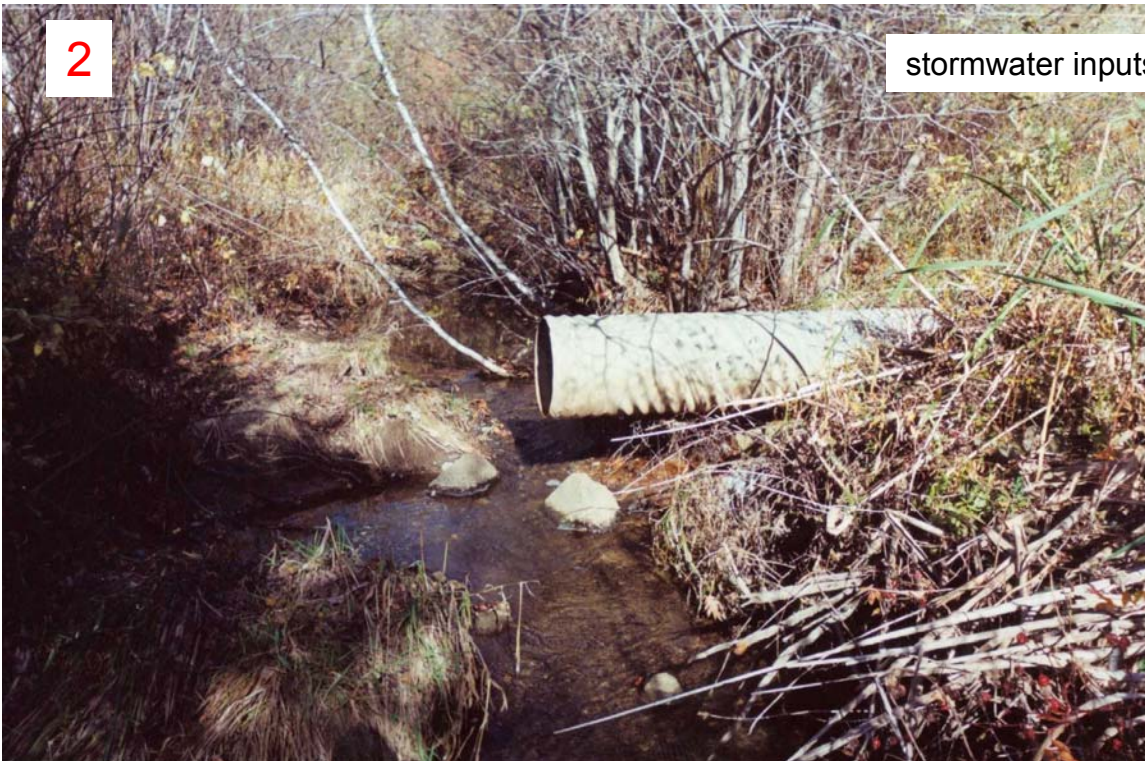
stormwater inputs; trash
